AERONAUTICAL RESEARCH LABORATORIES

STRUCTURES NOTE 445

### IMPACT TESTS ON CRASH HELMETS FOR MOTOR CYCLISTS

N. D. HEARN and S. R. SARRAILHE

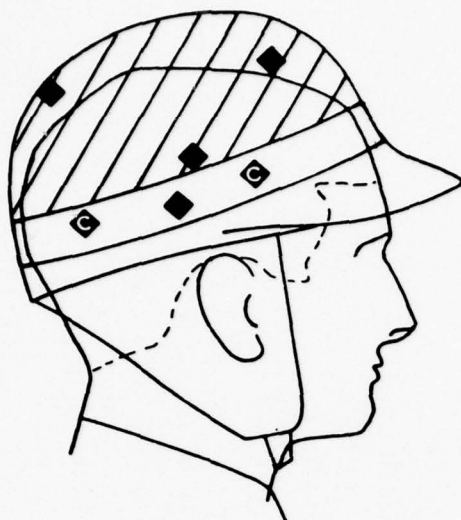
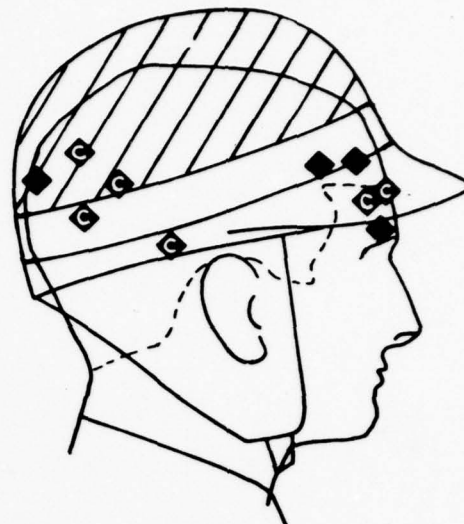
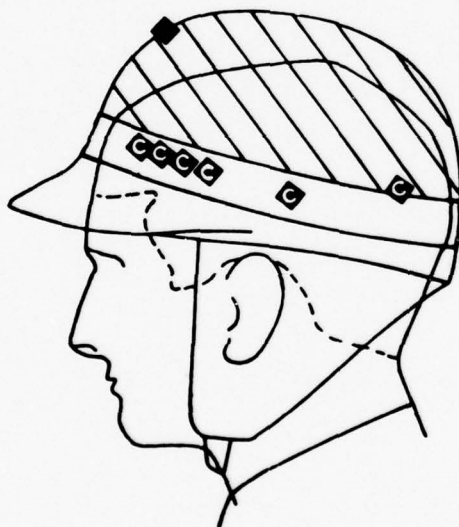
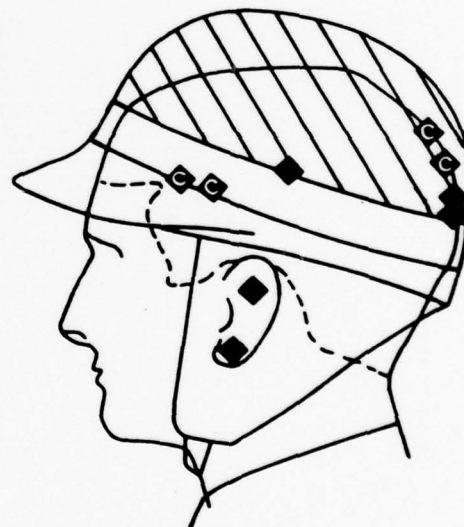
FIG. 1 IMPACT LOCATIONS FROM A SURVEY OF TRAFFIC ACCIDENTS (Reproduced from Ref. 8)

Cases where a helmet was worn, showing the position of impacts in relation to the shell of the helmet and the protective padding. The cross-hatched area indicates the extent of the padding. 'C' indicates an impact causing concussion.

Cases where helmets were not worn, showing the position of the impacts in relation to the area covered by the shell of the helmet and its protective padding. The cross-hatched area indicates the extent of the protective padding. 'C' indicates an impact causing concussion.

Accident data from several sources including an Australian survey (in 1966) indicate that in accidents the impact is most likely to be near the edge as shown in Figure 1; moreover the authors<sup>6</sup> observed that:

"50 per cent of this series of impacts fall in an area where there is no protective padding in the standard helmet."
